ACPA » Project Profile

Box Culvert Creates Efficiencies for Bridge Repair

In October 2020, Iowa opened a newly rehabilitated bridge on Highway 3 in Plymouth County. Installing twin precast concrete box culverts under the existing bridge instead of a full bridge replacement enabled busy Highway 3 to remain open throughout the repairs. Box culverts were the perfect solution.

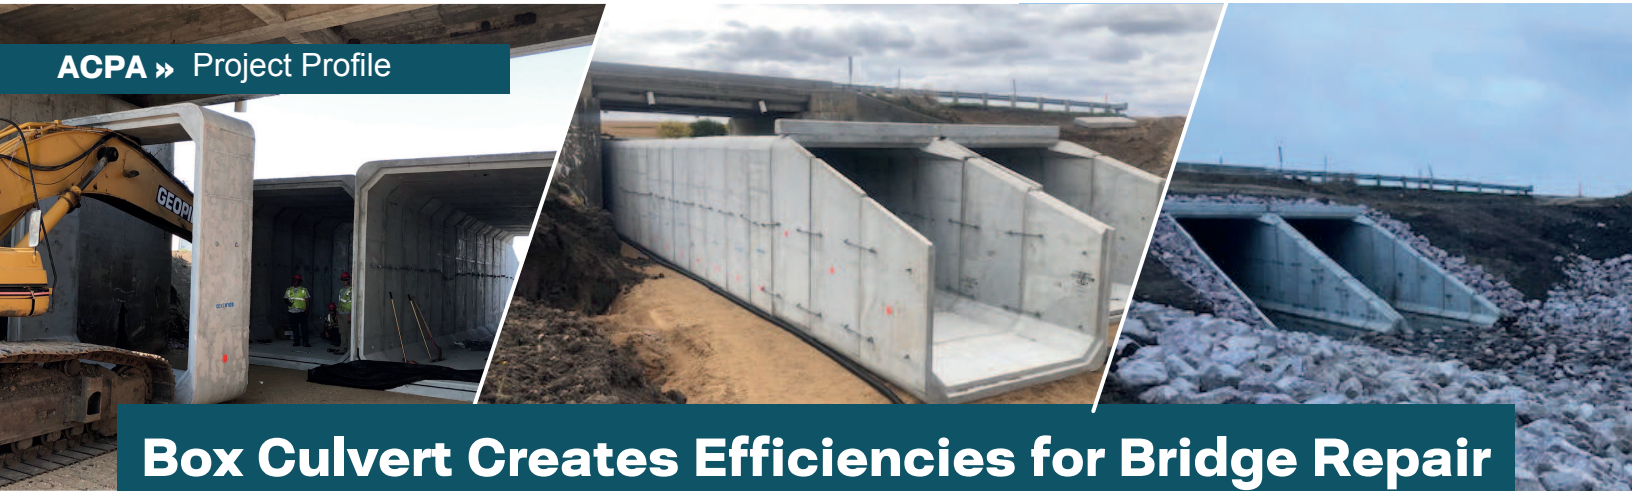
The project design called for PCI to use two 12- by 12-foot box culverts installed side by side with 3/1 sloped end sections. Each culvert measured 117 feet long, consisting of 13 x 4-foot sections and 13 x 5-foot sections. A total of four end sections measured 35 feet each.

An interesting twist to this project was that the twin culverts had to be installed under the existing bridge. Normally the road is closed, the bridge is removed, the culverts are installed, and the road reopens. In this case, Iowa DOT wanted to keep the traffic flowing on the highway without disruption, so the bridge was kept intact during the new culvert's construction.

PCI installed one section at a time. The biggest challenge was to carefully slide the precast concrete culvert sections into place without destroying the grade. Using a 110-ton Link-Belt crawler crane and a 345B Caterpillar excavator, each culvert piece was slowly walked into place and carefully pulled together. Even with the added caution, the slide required PCI to continually adjust the grade throughout the installation.

After the box was installed, the guardrails were removed and any spaces between the box culvert and existing bridge were filled. Next, holes were drilled in the existing bridge deck, and a flowable grout was pumped through to fill the void between the top of the box culvert and the bottom of the bridge. When complete, a new asphalt overlay was placed on the bridge, and grading was completed around the outside of the culvert ends.
